Improving Utah's Water Quality

East Canyon Watershed

East Canyon Water Quality Improvement

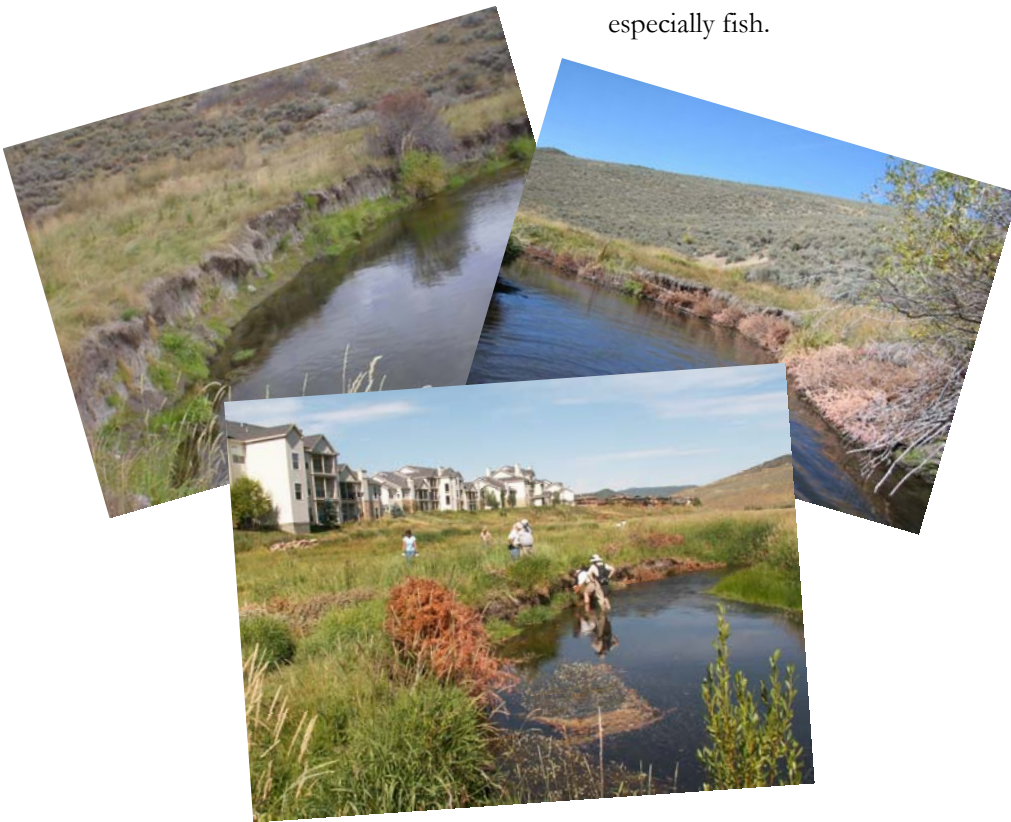
To improve fish habitat, a cross vane structure has been constructed in the stream channel which improves habitat by creating a scour pool. Deep pools as well as riffles and runs are important features for many types of aquatic organisms, especially fish.

Beginning in spring of 2005 the Swaner Nature Preserve began implementation of a stream restoration project on East Canyon Creek. The main goals of this project are to stabilize eroding stream banks, restore riparian vegetation, and improve fish habitat over 5 years. Stream bank erosion can cause too much sediment to enter a waterway, which can affect the natural function of the stream or creek. As of January 2007, over 1100 feet of eroding stream banks have been stabilized using brush revetments. The revetments were installed by volunteers and help to hold the eroding banks in place, preventing the sediment from washing into the water. The revetments in East Canyon Creek were constructed using recycled Christmas trees from the Park City area.

Riparian vegetation is being restored by planting various trees and shrubs along the creek. Approximately 760 trees and shrubs have been planted in the project area along with 1800 willow cutting transplants. The roots from the planted vegetation will help hold the soil in place, and provide habitat for wildlife who use the area.
